**US Army Corps
of Engineers®**
Engineer Research and
Development Center

Feasibility Investigation into Strengthening of Timber Bridge Stringers

Final report

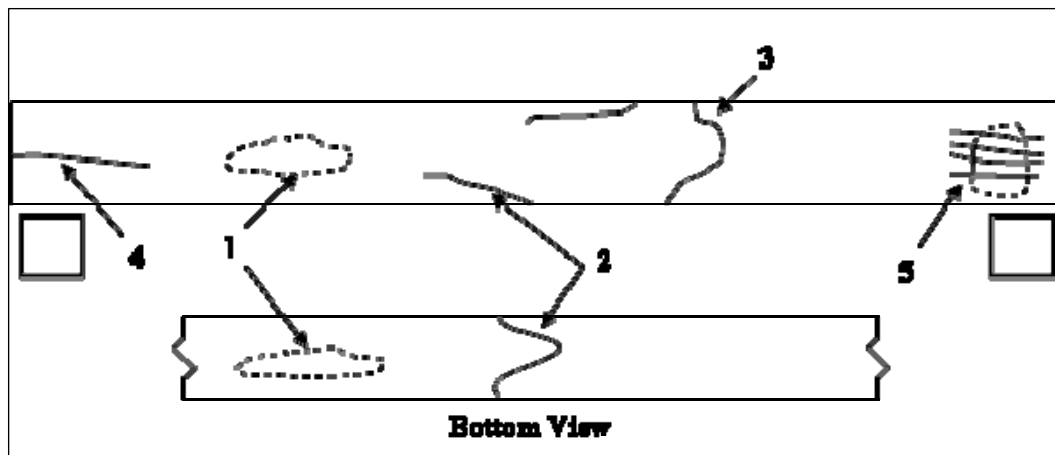
Timber stringers exhibit five types of damage, shown schematically in Figure 1. The first damage type is interior decay along the span. The second damage type is top, bottom, corner damage, or full width vertical splitting inclined toward the bottom face. The third damage type is side or corner damage or full width vertical splits inclined toward the side face. The fourth damage type is horizontal splitting not within 3 in. of the top and bottom faces through the full width. The fifth type encompasses any damage within 130 mm (15 in.) from the face of the pier cap, including interior decay, side damage, crushing, and splitting.

Figure 1. Schematic of stringer damage types.

The most commonly encountered damage type in timber stringers in bridge structures is type 4, horizontal splitting. These horizontal splits often stretch the entire length of the span. This splitting is induced by shear stresses and severely impacts the strength of the timber member.

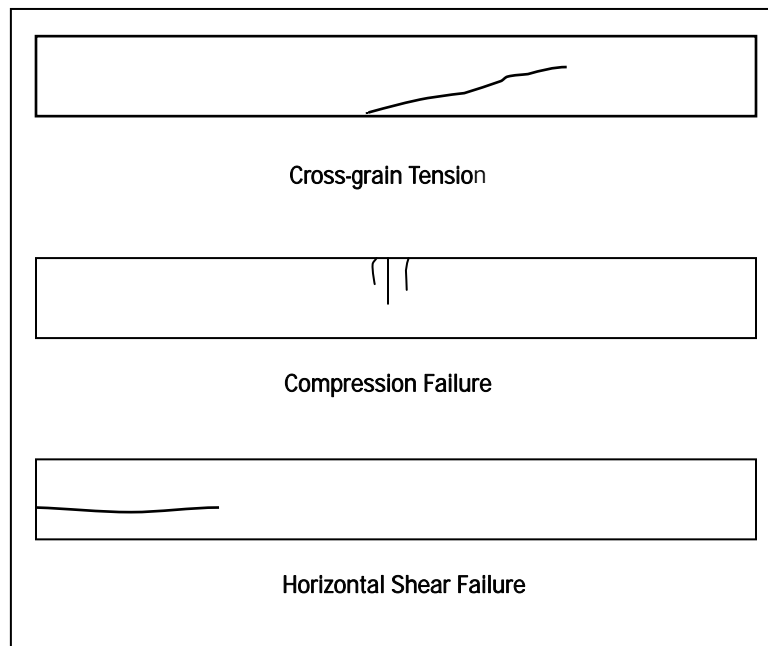
Defect-free wood specimens are called clear specimens. Several failure types for clear wood in bending have been observed during testing. The most common failure modes were horizontal shear, cross-grain tension, simple tension, and compression, as shown schematically in Figure 2. When cross-grain is present, a typical failure pattern is cross-grain tension. Compression failure typically occurs in low-density wood. Shear failure near the neutral plane occurs in species containing checks and shakes which can act as planes of weakness for shear failure (Bodig and Jayne 1982, ASTM D 143 1999, ASTM D 198 1999).

Figure 2. Failure types in static bending (adapted from ASTM D 143 (1999) and ASTM D 198 (1999)).

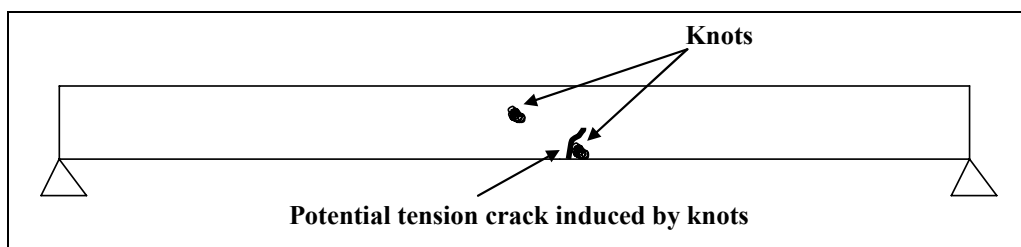
The discontinuity introduced by knots lowers the strength of the wood material. The effect of the presence of a knot on the tensile strength is greater than the effect on the compressive strength. Consequently, a knot near the bottom surface of a simple beam is less desirable than the same knot near the top surface of the beam, as shown in Figure 3.

Figure 3. Failure in bending caused by knots (adapted from Bodig and Jayne (1982)).

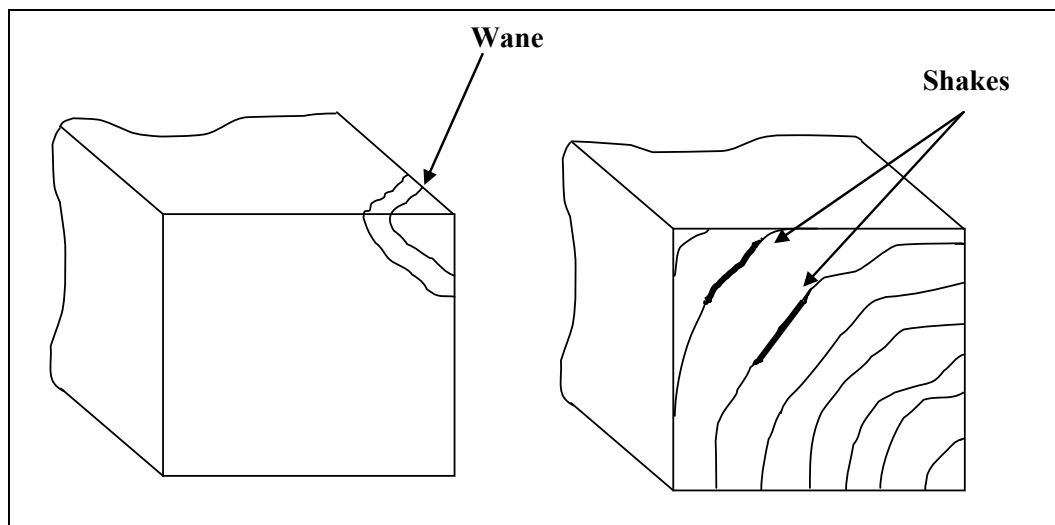
A wane is lack of wood on the edge or corner of wood members, and shakes are lengthwise separations in the wood occurring between annual rings, shown schematically in Figure 4. Rots are usually evidence of disintegration caused by bacterial action. Wood is susceptible to damage from fungus or insects, thus hardness and mechanical strength in the presence of rot are decreased. Several preservative treatments have practically eliminated decay; splits are usually the reason for the replacement of wood members. Checking and splitting can penetrate to the interior of the member, resulting in exposing untreated wood to decay fungi and insects, which negates the beneficial effects of preservative treatments.

Figure 4. Schematic of typical wane and shakes.

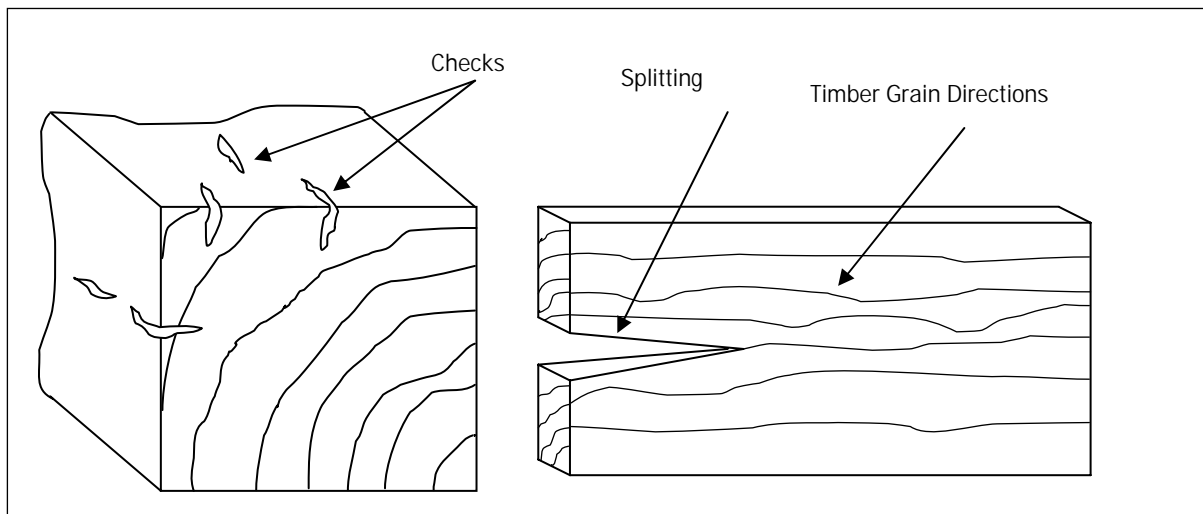
Checks and splits are lengthwise separations in the wood, occurring across the annual rings, as shown in Figure 5. Under typical conditions, wooden beams and columns may develop splits and checks. These splits and checks are a result of swelling and shrinkage from drying as the member equilibrates to the surrounding moisture condition, or from repeated wet/dry moisture cycling. Splits and checks are commonly encountered in exposed timber bridge stringers and in timber columns (Rammer and McLean 1996; Rammer, McLean, and Cofer 1998). Heart checks are a result of stresses set up by differences in tangential and radial shrinkage of wood around pith, as shown in Figure 6. (Green, Falk, and Lantz 2001).

Figure 5. Schematic of typical checks and splits.

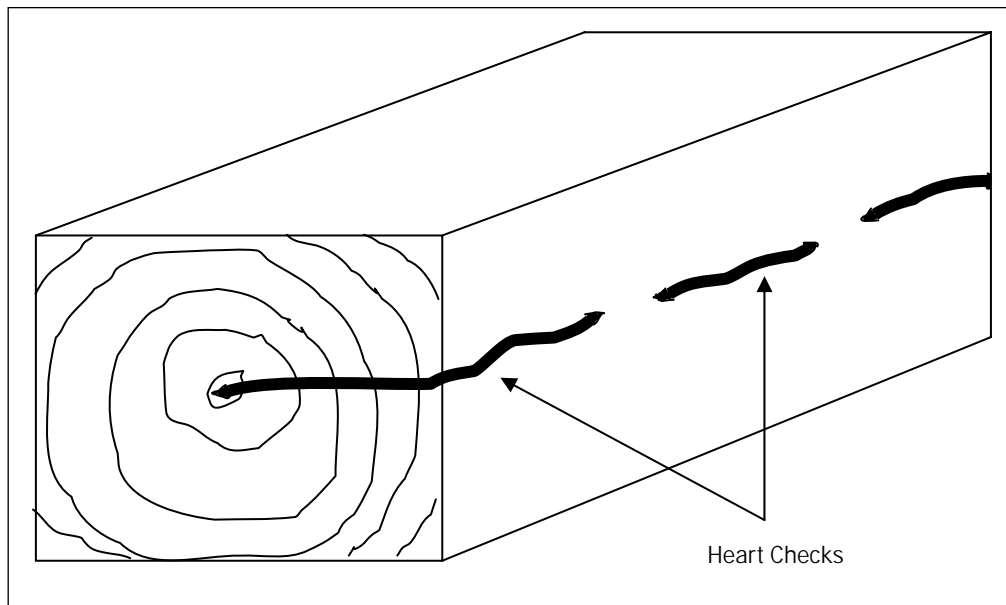
Figure 6. Schematic of heart checks (adapted from Green, Falk, and Lantz (2001)).

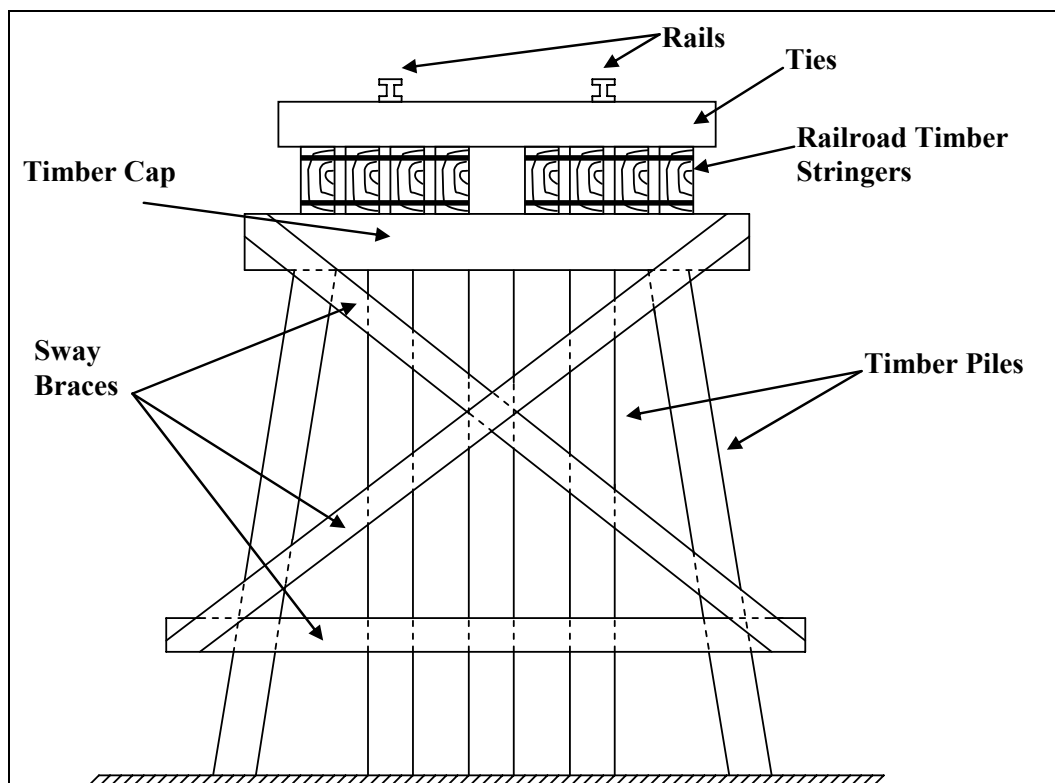
Figure 7. Typical cross-sectional view of a railroad bridge (adapted from Wipf, Ritter, and Wood (2000)).

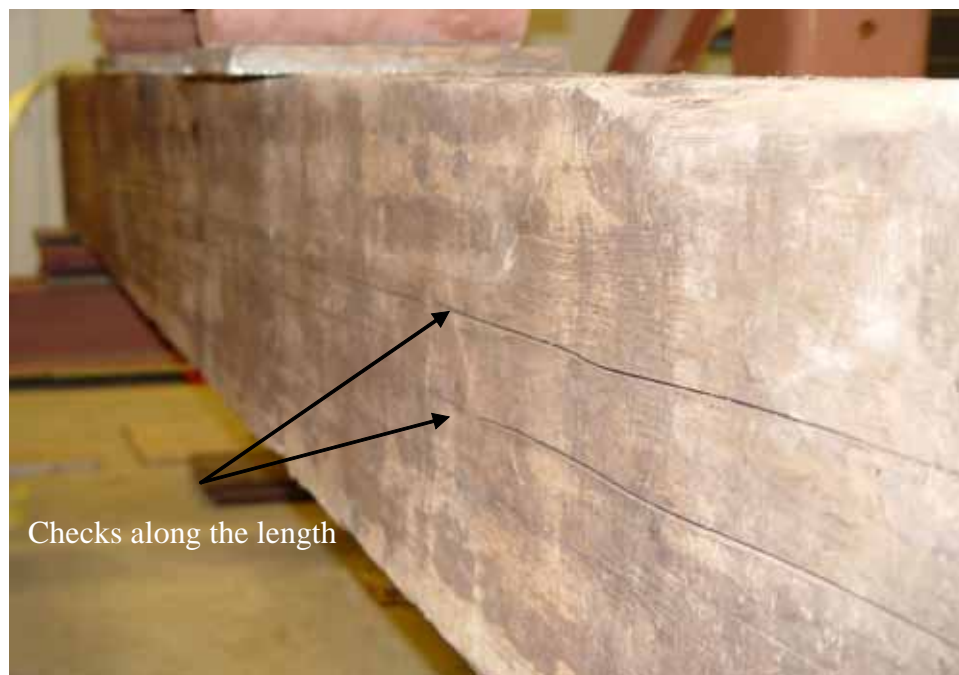
Sixteen 191 mm by 406 mm by 4.6 m (7.5 in. by 16 in. by 15 ft) timber stringers were obtained from a railroad bridge recycling yard near San Marcos, TX. The timber specimens were classified as beams and stringers (AFPA 1996). Most of the stringers had signs of checking and horizontal splitting. An example of checking is shown in Figures 8 and 9. Some timber stringers had severe horizontal end splits, as shown in Figure 10. All timber stringers were graded select structural and were pressure treated with creosote. All of the timber stringers tested in this study had two horizontally drilled holes at their ends, as shown in Figure 11. These holes were drilled to connect stringers together when they were put into service in a railroad bridge.

Figure 8. Several checks along the length of a timber stringer.

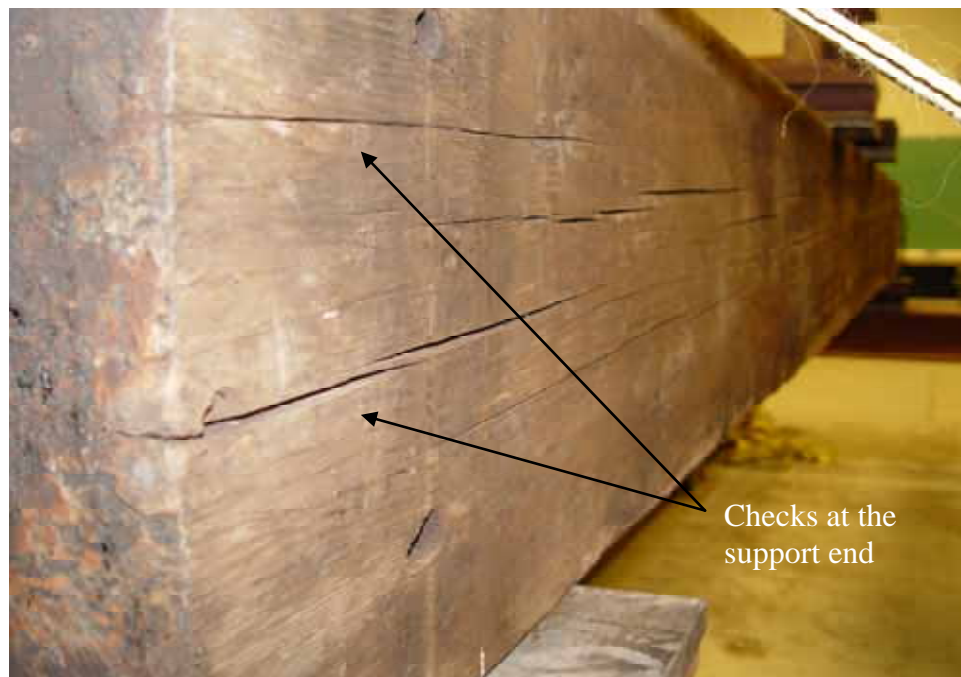
Figure 9. Several checks at the end of a timber stringer.

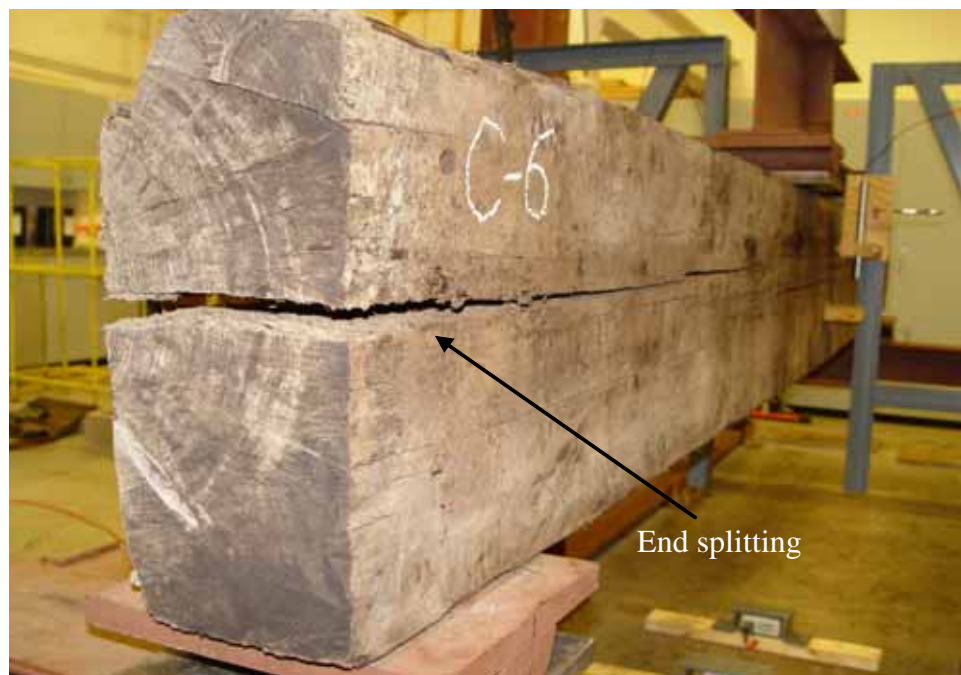
Figure 10. Timber stringers with end splits.

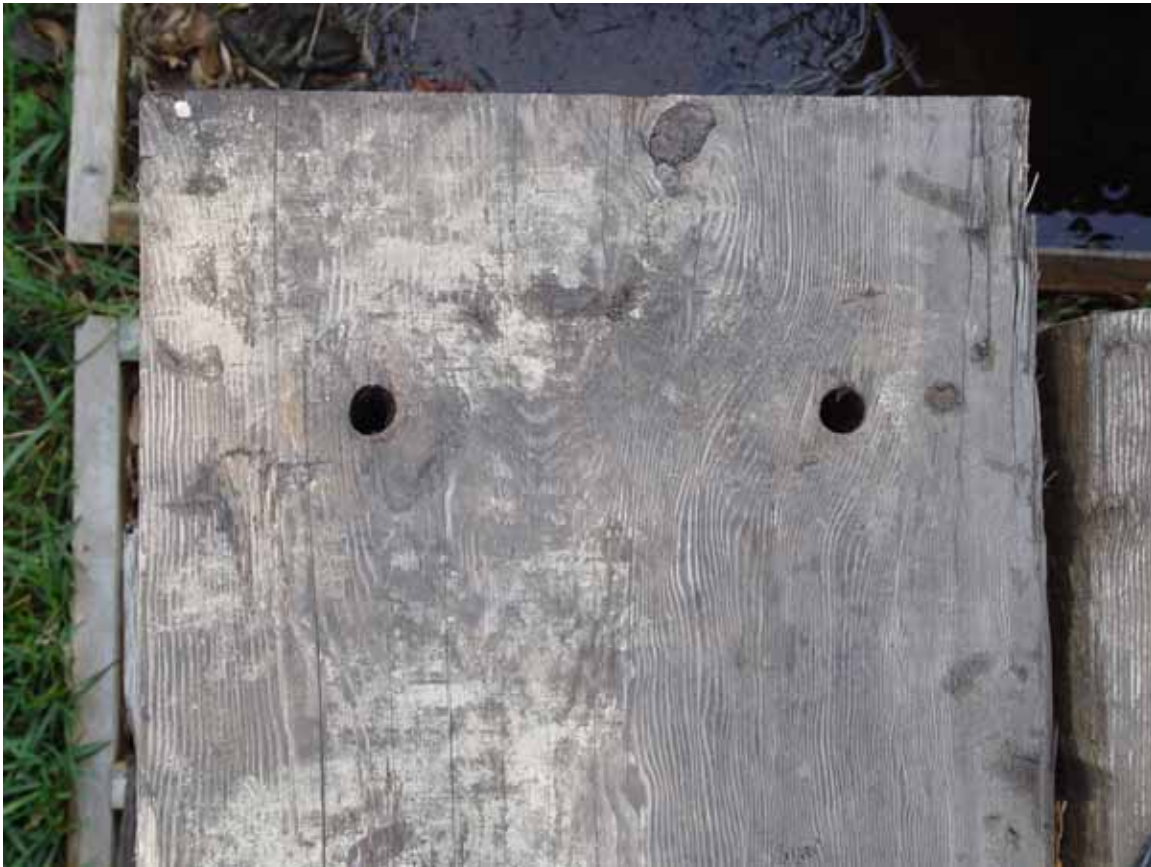
Figure 11. Horizontally drilled holes at the ends of the stringers.

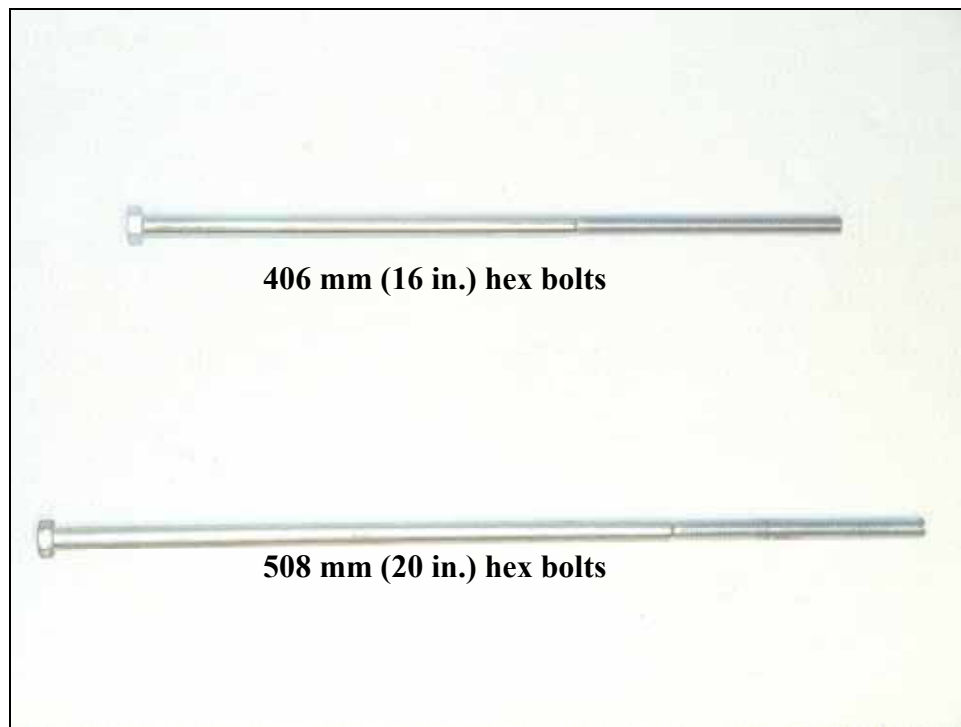
Partially threaded steel hex-head hex bolts and lag screws were obtained from McMaster-Carr and Barnhill Bolt Co., Inc. Hex bolts were 13 mm (0.5 in.) in diameter. Two different lengths, 406 mm and 508 mm (16 in. and 20 in.), shown in Figure 12, were used to repair the timber stringers which had horizontal splitting. Hex bolts had 1/2 in.-13 threads. Minimum tensile and shear strength of the hex bolt material were 414 MPa (60,000 psi) and 232 MPa (33,600 psi), respectively.

Figure 12. Two different length hex bolts.

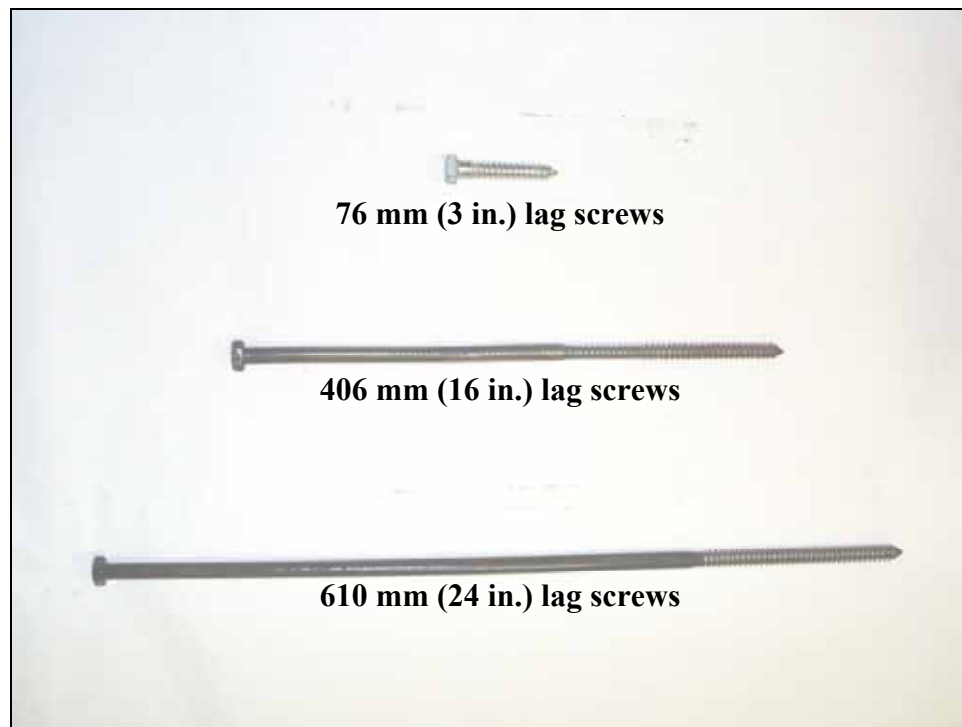
The lag screws used in this study were 13 mm (0.5 in.) in diameter. Lengths of the lag screws were 76 mm, 406 mm, and 610 mm (3 in., 16 in., and 24 in.), as shown in Figure 13. The lag screws were not only used perpendicular to the timber fiber direction, but also as inclined reinforcing members in the timber stringers. The 406 mm and 610 mm (16 in. and 24 in.) lag screws were used directly for repairing and strengthening, while the 76 mm (3 in.) long lag screws were used to attach side plates to the timber stringers. The lag screws had 1/2 in.-13 threads. They are made of zinc plated grade 2 steel and were not corrosion resistant. Tensile and shear strength of the lag screws were 310 MPa (45,000 psi) and 174 MPa (25,200 psi) (AFPA 1996), respectively.

Figure 13. Three different length lag screws.

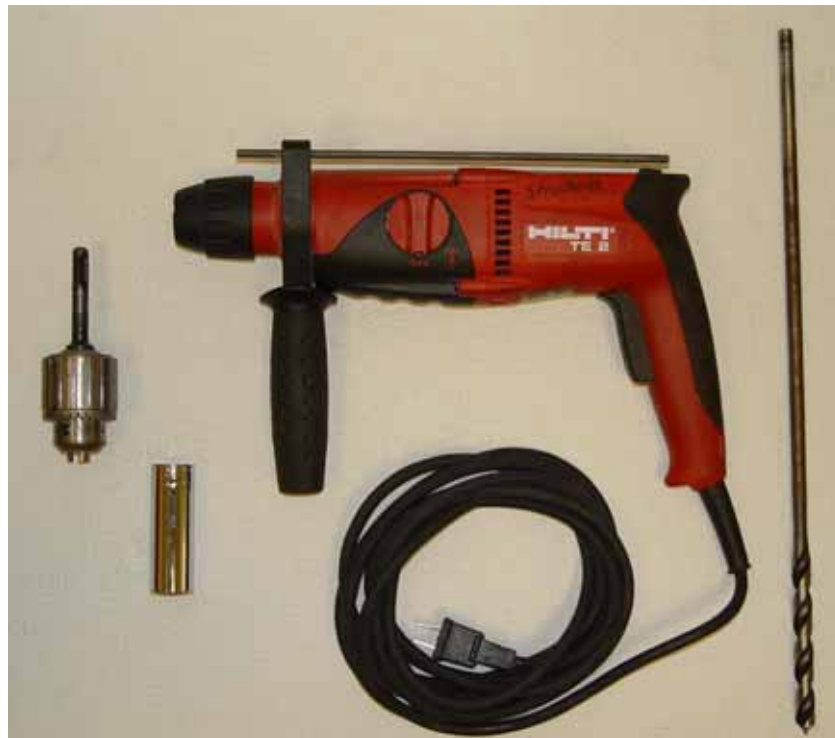
Model TE 2 and TE 35 drilling tools manufactured by Hilti were used to drill the holes and to install the hex bolts and lag screws in the timber stringers. The TE 2 had an input power of 600 W and an output of 1200 rpm. Hilti drill TE 35 had an input power of 830 W and an output of 620 rpm. The TE 2 is shown in Figure 14 and the TE 35 is shown in Figure 15. The TE 35 was also used to attach the side plates using 76 mm (3 in.) lag screws. Holes were drilled using 13 mm (0.5 in.) diameter and 457 mm (18 in.) long drill bits manufactured by Irwin, Inc.

Figure 14. Hilti drill model TE 2 and drill bit.

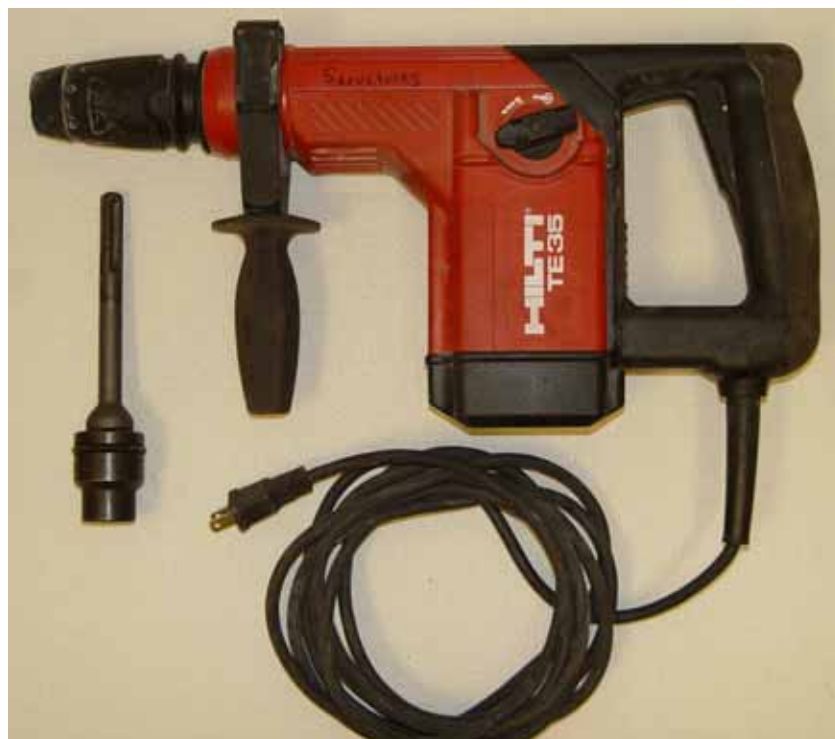
Figure 15. Hilti drill model TE 35.

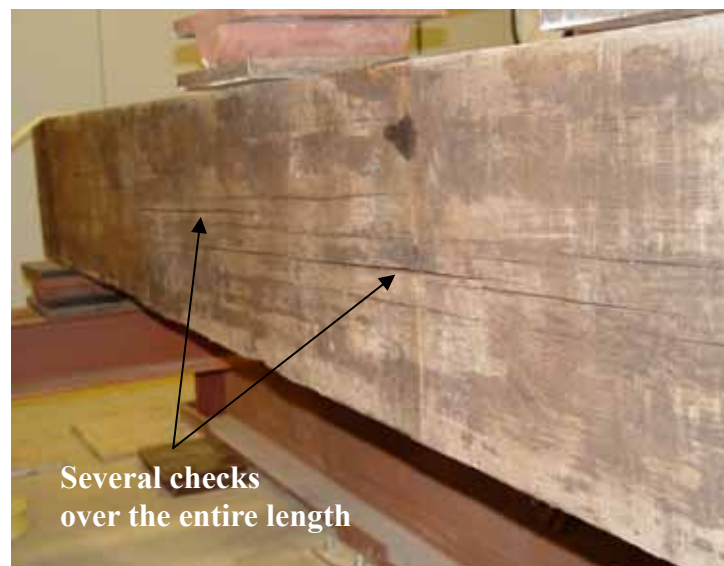
Stringer C1 was a control specimen. The stringer was in good condition except for several checks at the ends and along the length. Figure 16 shows several checks caused by unequal drying of the timber stringer. Checks were readily observed only on one side of the stringer. Specimen C1 did not have any deterioration at the tension zone or near the support points before testing.

Figure 16. Checks along the length of specimen C1.

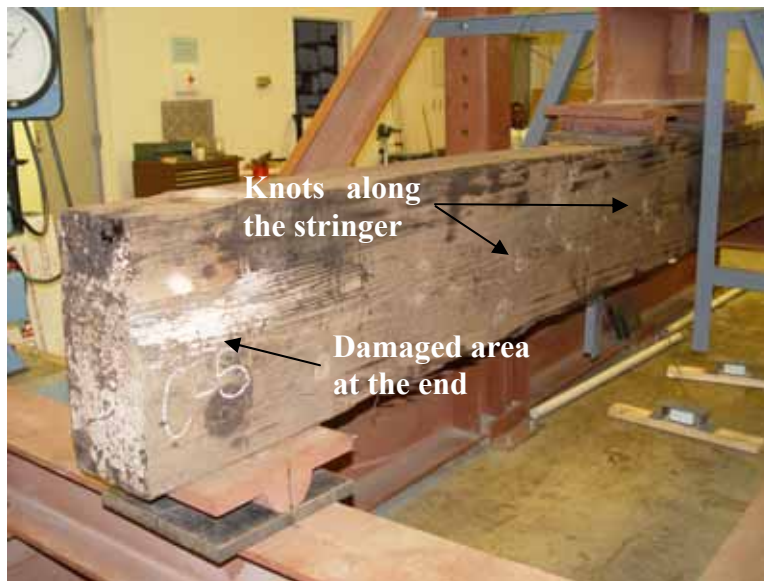
Specimen C5 had several knots along its length. The knots were located close to the center of the stringer, as well as in the tension zone near the midspan. The knots in the tension zone were expected to reduce the strength of the stringer. C5 also had several checks along its length; however, the checks were seen only on one side of the stringer, as in the case of specimen C1. There was a damaged area close to the center of the cross section at the end of the stringer, as shown in Figure 19. It was not expected that this damaged area would affect the strength of the specimen C5.

Figure 19. Damaged area close to the support and knots on specimen C5.

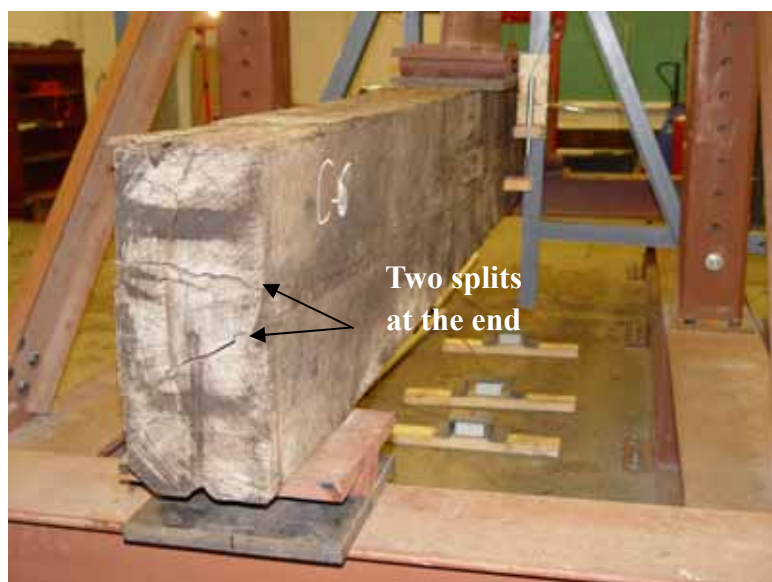
Specimen C6 had severe end splits at the ends and along its length. Continuous splits were observed starting from the ends to the midspan of the stringer. These splits are typically caused by uneven drying of timber stringers. Splitting on the support face was close to the center of the cross section, where shear stress was at a maximum. The other support end had several splits on the cross section. The stringer also had several checks and other damage at the support edges, as shown in Figures 20 and 21.

Figure 20. Splitting at the ends and along the length of specimen C6.

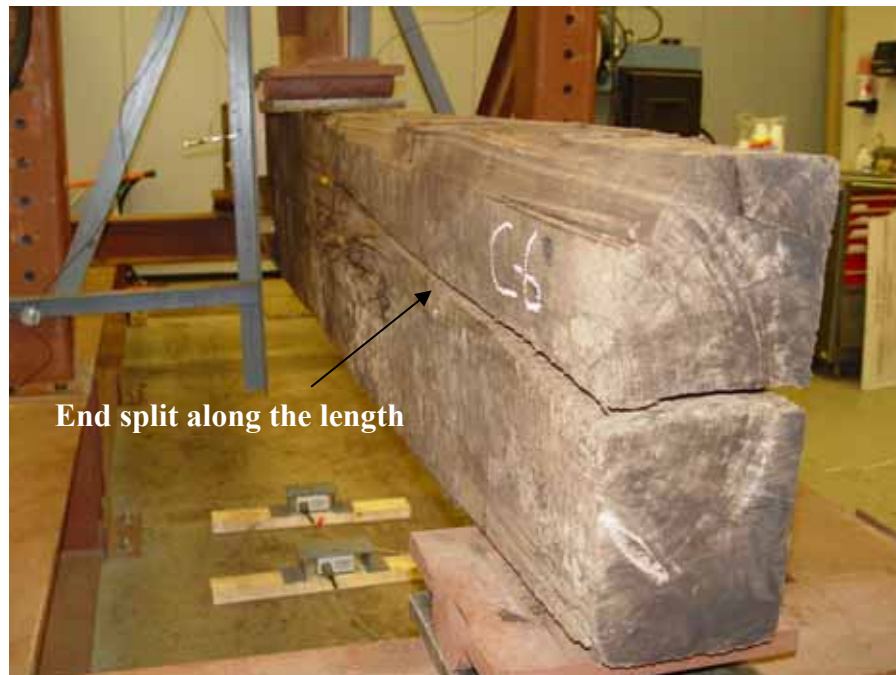
Figure 21. Splitting at the ends and along the length of specimen C6.

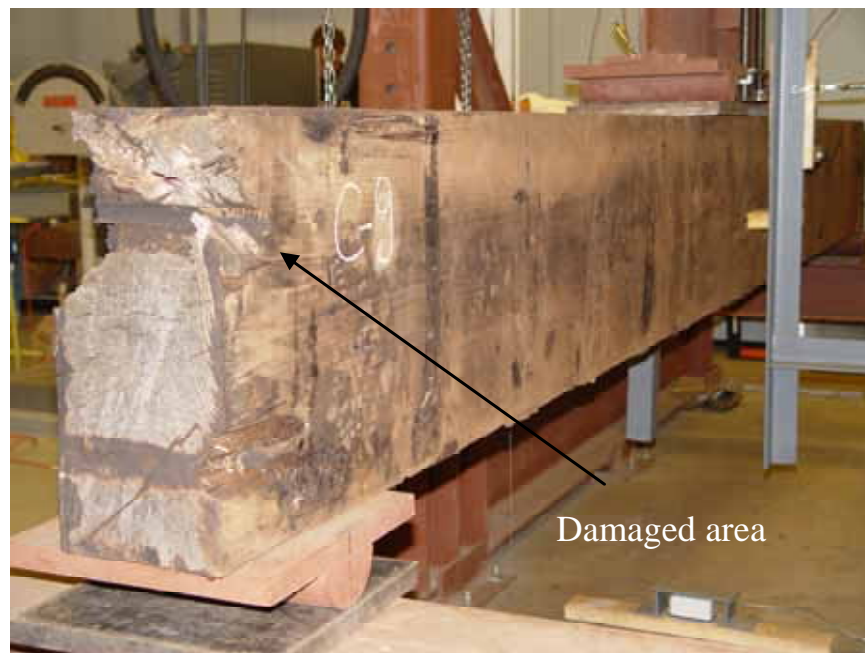
Specimen C9 had several knots and small checks along its length. The knots at the midspan were expected to reduce the strength of the stringer. There was also a damaged area at the support end, as seen Figure 23.

Figure 23. Damaged area at the end of specimen C9.

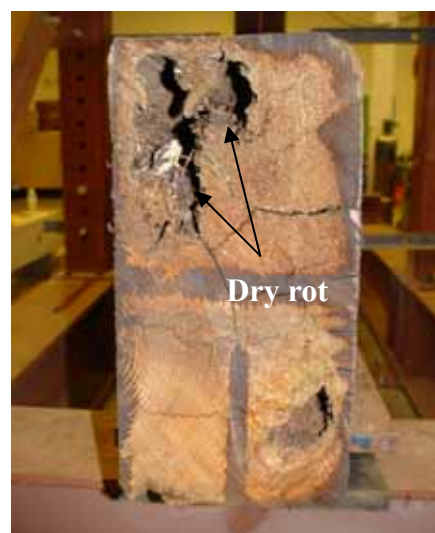
Specimen C11 showed signs of deterioration at one end support. The cross section at the support point was rotted and had several shakes, as shown in Figure 25. After this stringer was repaired and tested, it was cut into small pieces to see if the rotting penetrated inside the stringer. Rotting was also observed at pieces cut at midspan. The stringer had checks along the length, and it had splitting at the other support end, as shown in Figure 26. The end split was only couple of inches long.

Figure 25. Rotting, shakes, and splits at the support end on specimen C11.

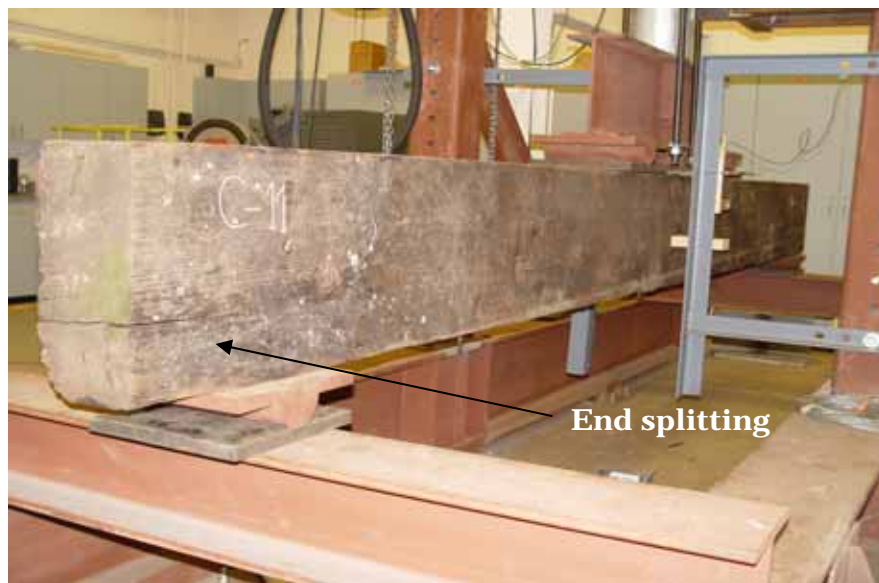
Figure 26. End splitting on specimen C11.

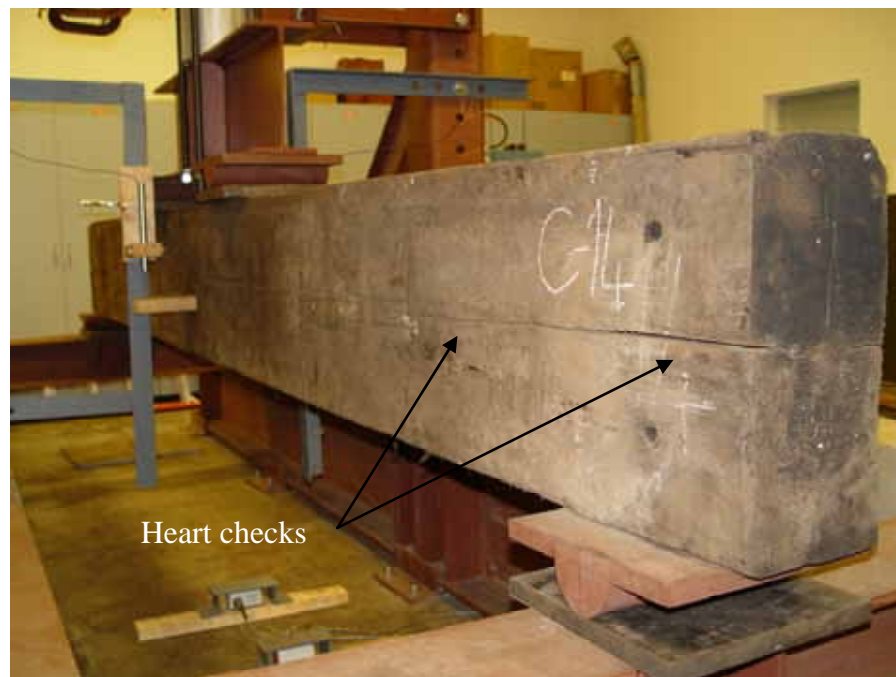
Specimen C14 had several heart checks observed along its length, shown in Figure 29. Heart checks were discontinuous and located close to the center of the cross section. The stringer did not have any other major deterioration that might affect its strength except for the heart checks at the ends and along the length.

Figure 29. Heart checks on specimen C14.

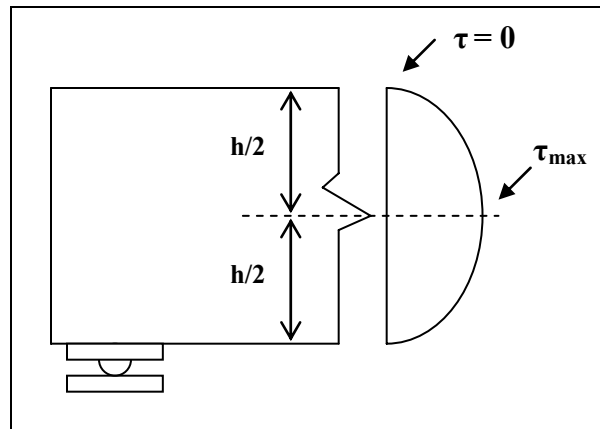
Hex bolts, lag screws, plywood, and FRP side plates were used as repair systems to increase the shear strength of the split stringers. Hex bolts and screws were used in several configurations and spacings to strengthen and repair the timber stringers. AFPA mechanical connection concepts were utilized to determine the required number of hex bolts and lag screws needed to repair timber stringers (AFPA 1996). The distribution of shearing stresses in the transverse direction of a rectangular stringer is parabolic, as explained in Appendix A. The timber stringers were assumed to have a split at the center of the cross section over the entire length, since the shear stresses are at their maximum at the center of the cross section, as shown in Figure 32. The shear stresses are also zero at the top and bottom of the cross section. In other words, a stringer that has a lengthwise split at the neutral needed hex bolts or lag screws to transfer

the maximum stresses, as explained in Chapter 2, “Literature Review, Shear strength of wood beams, Effects of splits and checks and shear strength.” The function of the repair system was to carry the maximum shear stresses of the total cross section over the entire length. Details of the computations performed to determine the required number of hex and lag screws to repair the timber stringers are provided in Appendix B.

Figure 32. Shear stress distribution on a cross section of timber stringers.

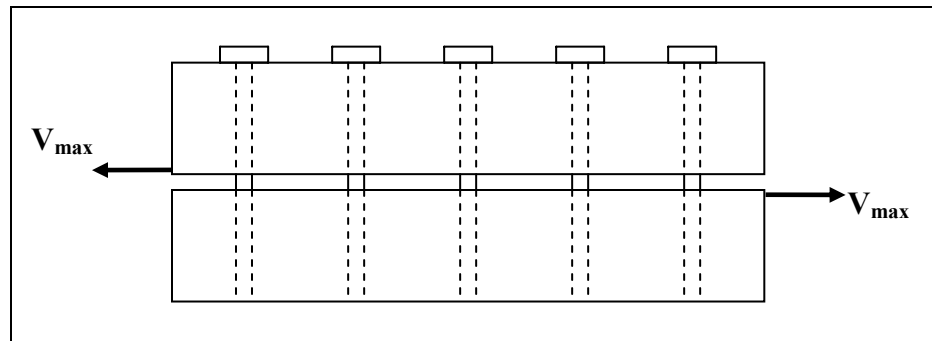
AFPA mechanical connection concepts were utilized to determine the required number of hex bolts and lag screws (AFPA 1996). A complete separation was assumed at the neutral plane, over the entire length of the stringers. The required number of hex bolts and lag screws were computed by modeling this system as a single shear connection, as shown in Figure 33.

Figure 33. Single shear connection model for hex bolts and lag screws.

The purpose of the hex bolts and lag screws was to transfer the shear stresses along the length of the stringers. The reference lateral resistance of one hex bolt and lag screw was determined using Section 7.5 of AFPA (1996). Section 7.5 provides six different failure modes for hex bolts and three failure modes for lag screws for a single shear connection. Among the failure modes, the one which gave the smallest value controlled the capacity of the shear connection. The required number of hex bolts or lag screws was then determined by dividing the maximum shear force at the cross section by the capacity of a single bolt. Yield mode IV controlled the capacity of the single shear connections for both the hex bolts and lag screws. Yield mode IV exhibits two yield points in the hex bolts and lag screws near each shear plane. The lateral resistance of one hex bolt or lag screw was calculated as 13 kN (3 kips). The maximum shear capacity (V_{max}) of 191 mm by 406 mm (7.5 by 16 in) timber section was 150 kN (33.6 kips). The number of hex bolts or lag screws (N_t) was then computed by dividing the maximum shear capacity of the cross section by the capacity of a single hex bolt or lag screw. Details of the calculations are provided in Appendix B. The required number of hex bolts or lag screws along the entire length of the stringers was calculated to be 12. However, a total of 13 hex bolts or lag screws were used at a spacing of 305 mm (1 ft) to make field application simpler reducing possible errors while measuring the spacing. Since the splits were not present over the entire length of the stringers, 7 hex bolts or lag screws were also used in some experiments placed every 610 mm (2 ft) to compare the effectiveness of the different repair systems. Bolts at the loading points were inserted right next to steel plates to prevent applying any load on top of bolts.

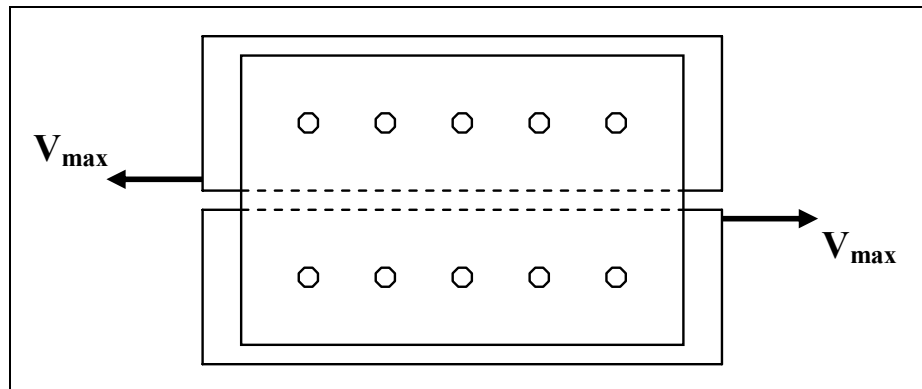
1996). A complete separation along the entire length of the stringers was assumed at the neutral plane as discussed in the previous section. The required number of lag screws was computed by modeling this system as a single shear connection, as shown in Figure 34.

Figure 34. Single shear connection model for side plates attached using lag screws.

The purpose of the lag screws and side plates was to transfer the shear stresses along the length of the stringers. The bearing capacity of the side plates and timber stringer was assumed equal. Reference lateral resistance of one lag screw was determined using Section 7.5 of AFPA (1996). Section 7.5 provides three failure modes for lag screws for a single shear connection. Among these failure modes, the one that yielded the smallest value controlled the capacity of the shear connection. Since separate side plates were used along the shear spans of timber stringers, the maximum shear force (V_{max}) on the cross section was divided by the number of plates to determine the force on each plate. Side plates were not used over the entire length of the timber stringers to prevent buckling problem at the midspan of the stringer. The required number of lag screws was then determined by dividing the shear force on each plate by the capacity of a single lag screw.

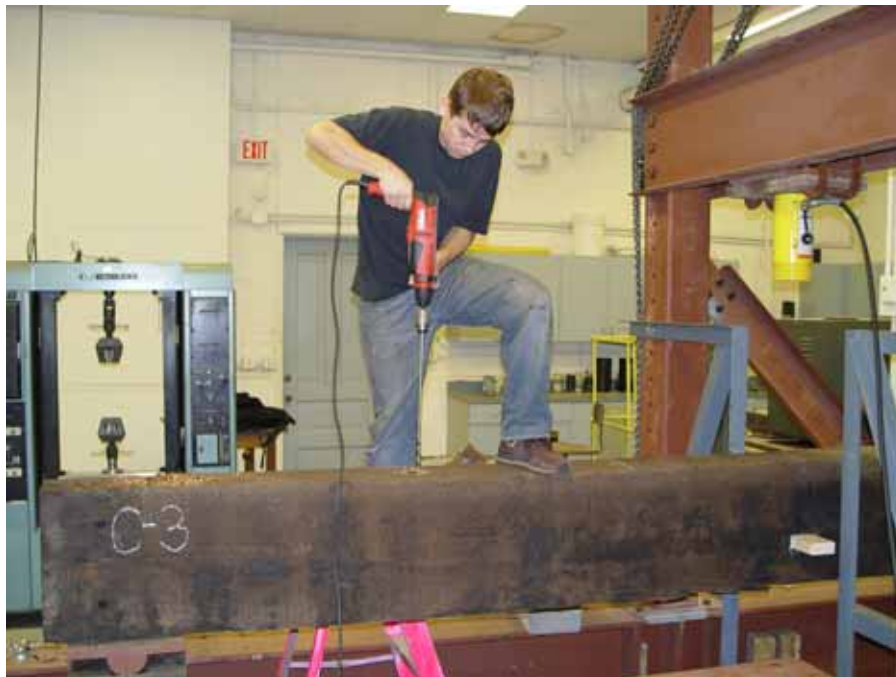
Specimens C2-R and C3-R were repaired using hex bolts and epoxy. A total of seven hex bolts were used at every 610 mm (2 ft). Hex bolts were 13 mm (1/2 in.) in diameter and 406 mm (16 in.) in length. Holes were drilled from top to bottom by using 13 mm (1/2 in.) wood drill bit and a Hilti TE-2 drilling tool, as shown in Figure 35. An epoxy mixture was prepared and applied to the inside of the holes and to the surface of the bolts individually, as shown schematically in Figure 36. After the epoxy was

Figure 35. Holes being drilled with TE 2.

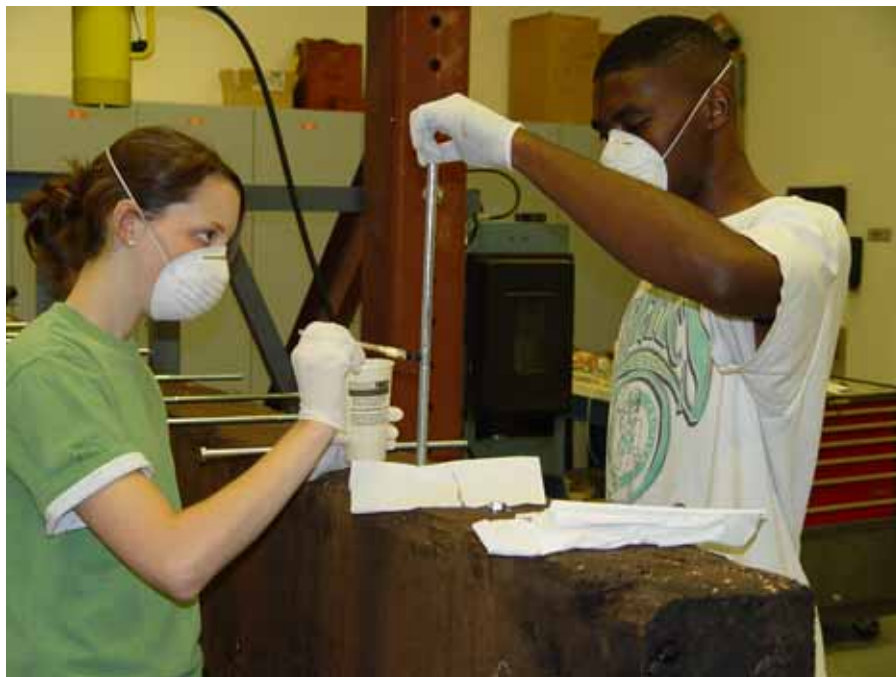
Figure 37. Epoxy being applied to the hex bolts.

applied, the bolts were installed in the holes, as shown in Figure 37. The bolts were then allowed to cure for 24 hr before testing. A stringer ready for testing is shown in Figure 38. Figure 39 shows a schematic of the hex bolt layout for specimens C2-R and C3-R.

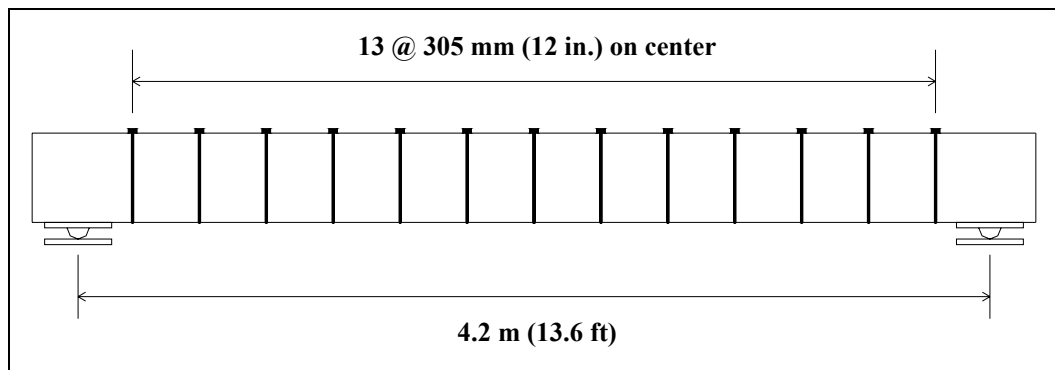
Figure 40. Schematic of hex bolt layout for specimen C4-R.

Specimen C4-R was repaired with hex bolts and epoxy, as were specimens C2-R and C3-R, but a spacing of 305 mm (1 ft) was used between bolts. Figure 40 shows a schematic representation of the repair method used for specimen C4-R. A total of 13 hex bolts were used. A picture of the stringer ready for testing is shown in Figure 41.

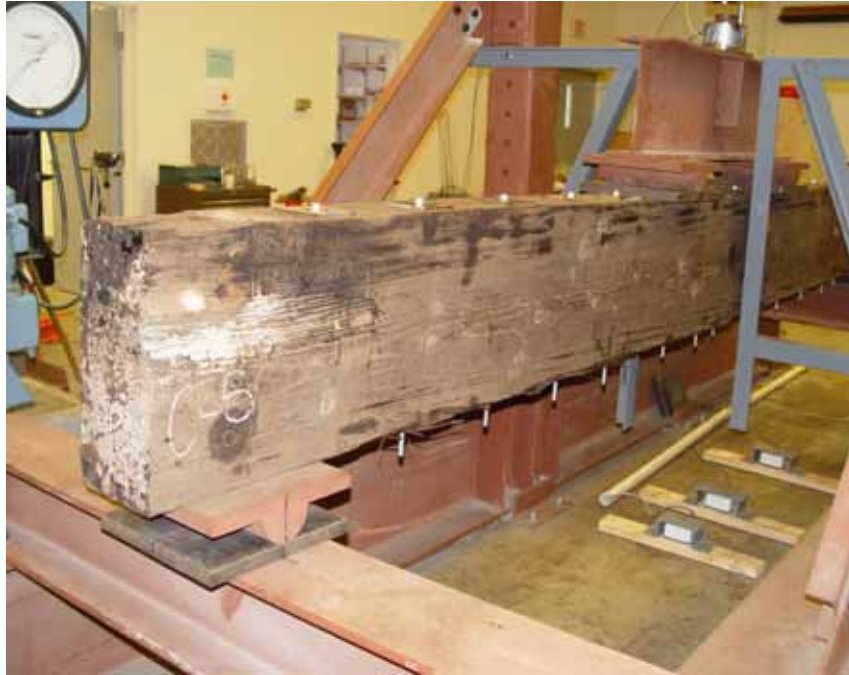
Figure 42. Specimen C5-R repaired with hex bolts and steel plates from top view.

Specimen C5-R was repaired using a total of 13 hex bolts with steel plates and washers, as seen in Figures 42 and 43. The hex bolts were 508 mm (20 in.) long and 12.7 mm (1/2 in.) diameter and were spaced 305 mm (1 ft) on centers, as shown schematically in Figure 44. The steel plates were 102 mm (4 in.) square and 6.4 mm (1/4 in.) thick. The plates were used in addition to the bolts, and were located between the bolt head or nut and the timber stringer, both on top and underneath the stringer at each bolt. Since the hex bolts and steel plates were tightened into place with nuts, epoxy was not used. Steel washers were used both at the top and bottom between the bolt head or nut and the steel plate. The plates were

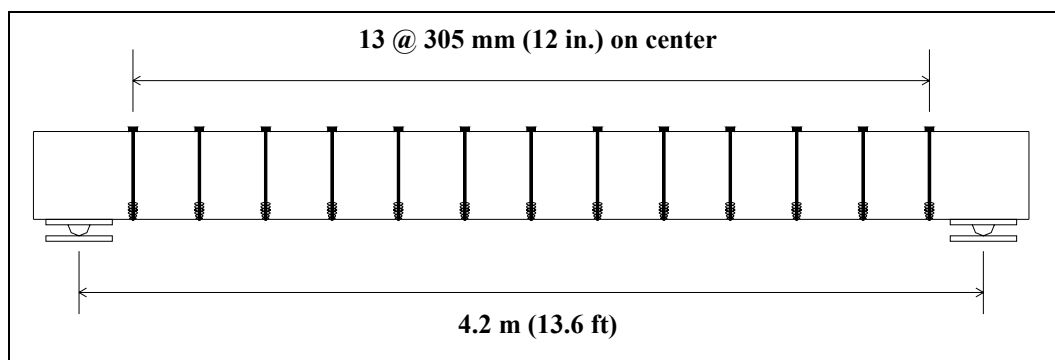
Figure 45. Schematic of lag screws layout for specimen C6-R.

Specimen C6-R was repaired with lag screws spaced every 305 mm (1 ft) on center, as shown schematically in Figure 45. The lag screws were 406 mm (16 in.) long and 13 mm (1/2 in.) in diameter. Holes were drilled in the transverse direction using the Hilti TE-2 drilling tool and a 13 mm (1/2 in.) wood drill bit. The 13 mm (1/2 in.) diameter lag screws were driven into the holes by the Hilti TE-35 drilling tool. Epoxy was not used with the lag screws.

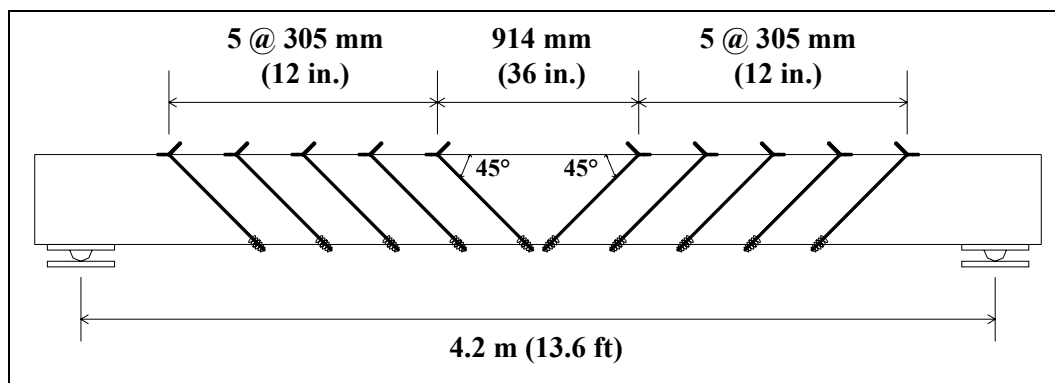
Figure 46. Schematic of lag screws layout for specimen C7-R.

Specimens C7-R and C10-R were repaired with lag screws. Specimen C10-R was repaired in the same fashion as specimen C7-R, but the 45° angle of the lag screws was installed in the opposite direction, as shown

schematically in Figures 46 and 47. A total of 10 lag screws were used to repair both timber stringers. The lag screws were 13 mm (1/2 in.) in diameter and 610 mm (24 in.) long. After marking points spaced at every 610 mm (2 ft) on the top of the stringer, guidelines at 45° to the transverse direction were drawn from the marked points to the bottom of the stringer. Holes making 45° angle with the transverse direction were then drilled along the guidelines using a 13 mm (1/2 in.) wood drill bit and the Hilti TE 2 drilling tool. Epoxy was not used with lag screws. The repaired stringer with lag screws is shown in Figure 48.
